TWIN CREEKS ESTATE

Community Update

In the latter half of 2016 the following improvements to the community facilities were completed:

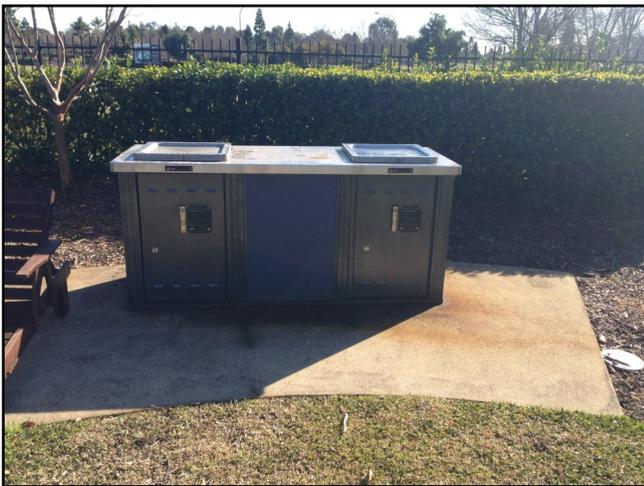
Safety BBQ prior to removal

This project included the removal of the original “safety” designed BBQ from the Community Facilities as the original BBQ was impractical and not utilised.

- The gas line connection was terminated by a qualified plumber. The BBQ was demolished and the concrete base was removed. The gas line was left in place as a provision for potential future use for other purposes.
- A new steel garden edge was installed to match the existing garden bed edging of the area.
- The concrete pad was then cut up to be reused and relocated adjacent to the Community Facilities function room.
- A layer of mulch was applied to the garden bed area to cover the space after the removal of the BBQ.

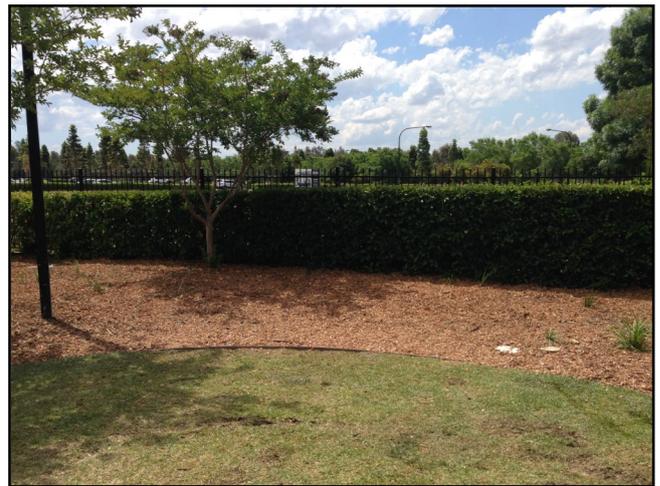
After removal of BBQ and Concrete Pad

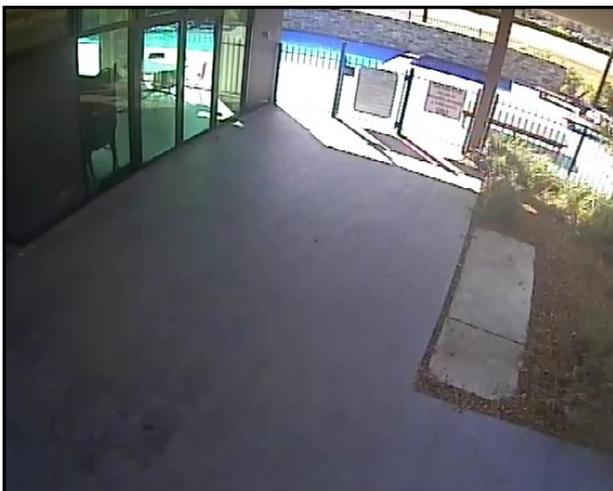
Repurposing and relocation of concrete pad

The concrete pad that was removed from the BBQ was custom cut and relocated to the garden bed area adjacent to the function room. This concrete pad is intended to be used as a base for the mobile BBQ that is available to residents hiring the community facility.

A second concrete pad was also cut as a provision for the future garbage bin enclosure.

The area surrounding the concrete pads were also mulched.

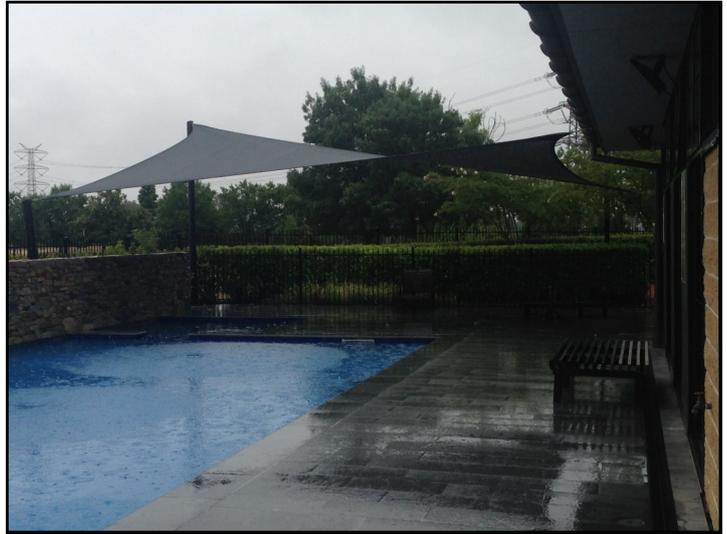
Pool Shade Sail

A shade sail was installed at the end of the swimming pool to provide a shaded area over a section of the pool and paved area.

- The sail is a standard 99% UV shade sail for commercial applications.
- Materials include stainless steel fixtures and powder coated steel support pole.

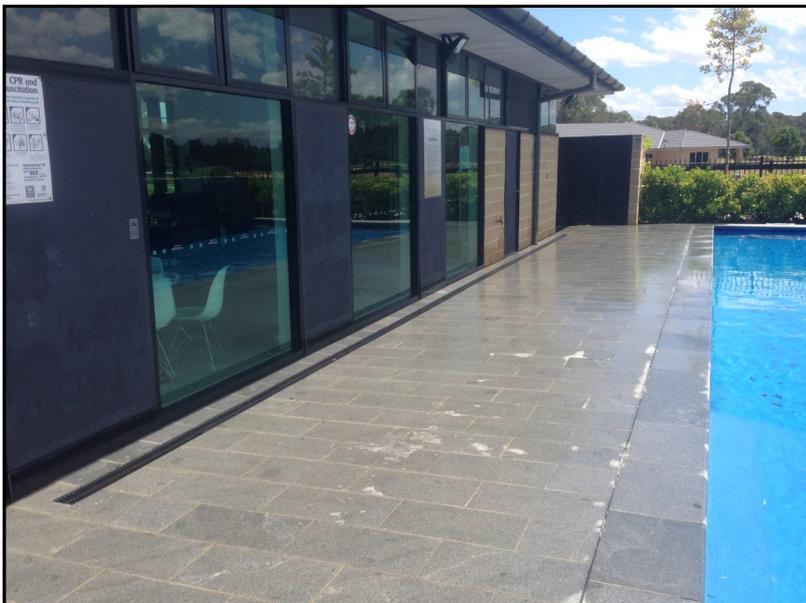
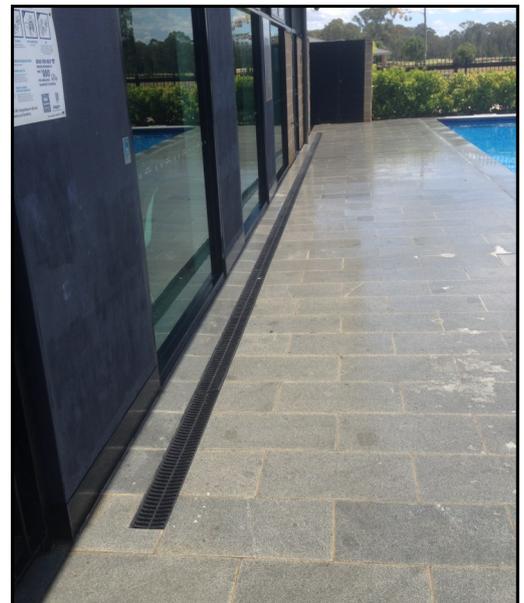
The original pebble drain located inside the swimming pool area has been replaced with better suited grate drain thus eliminating the distribution of pebbles in wet areas and to prevent pebbles from collecting inside the swimming pool.

New drain to replace previous pebble drain

- The original pebbles and Ag pipe were removed and the base of the drain re-established.
- A channel drain was custom fitted and installed to allow for the appropriate drainage of water. The drain was connected to the existing stormwater outlets.
- A grate was installed in black to match the colour scheme of the Community Building and silicone attached to help avoid unnecessary removal.
